Streambank Stability and the Presence of Invasive Riparian Vegetation in the Marshalls Creek Watershed, PA

Michal Niemczynski, Mark Kilker, Brent Hartle, Mark Edwards, Jake Brunkard, Molly Brunkard, East Stroudsburg University East Stroudsburg, PA
 Advisors: Shixiong Hu Geography Department and Jerilyn Jewett-Smith Biology Department East Stroudsburg University East Stroudsburg, PA

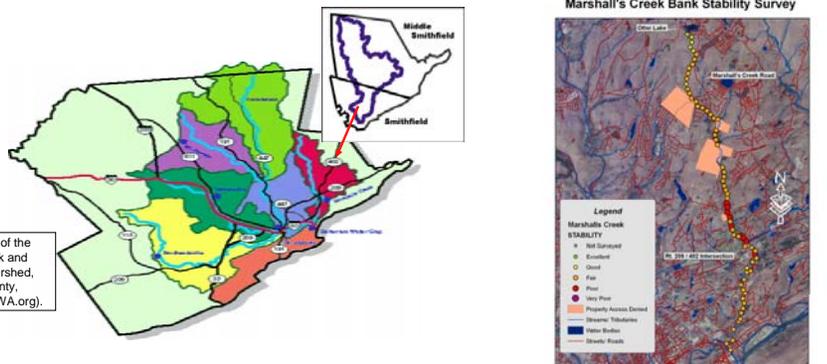
Figure 2: Marshall Creek Watershed bank stability map: each color indicates a specific stability level from excellent (green) to very poor (dark red)

Bank Stability: Preliminary analyses of the bank stability suggests that bank erosion is present in moderate to severe amounts from upstream to downstream. None of them shows excellent conditions. The upper stream seems in a good condition of bank stability. The section close to Route 209 shows great degradation of bank stability, which will be the first priority for bank stabilization in the watershed (Fig. 2). All the other sections indicate fair conditions, which need to keep it from further bank erosion.

Bank stability: Results indicate that 1) the banks close to Route 209 have been subjected to significant erosion due to the flooding events 2) this erosion has created instability in stream banks that endangers private property as well as municipal and state roads 3) future floods will cause extensive damage if no measures are taken to stabilize the banks in the middle and low reaches.

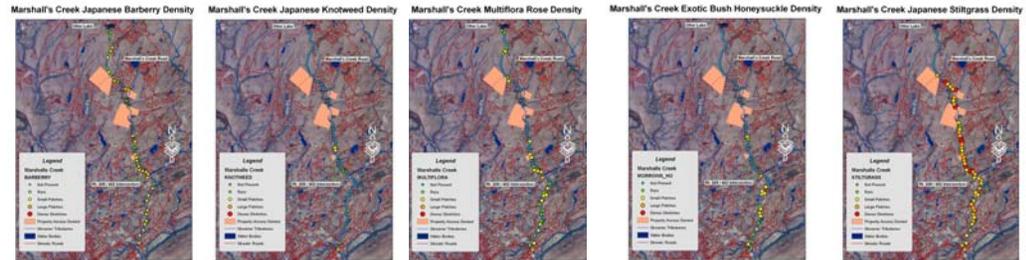
Fig. 3: Brodhead Watershed barberry densities

Invasive Vegetation Presence: Although eleven invasive species were identified in our study, there were three prevailing species. Figures 3-7 are maps that display where and how dense the species are in that area. Japanese Stiltgrass (*Microstegium vimineum*) was found in 74 % of sites, with an average density of 2.74 on a 1-4 Scale. Stiltgrass shows a heavy concentration in the middle of the watershed, but is absent upstream and not nearly as dense downstream. Japanese Barberry (*Berberis thunbergii*) is found throughout the entire watershed, although it does show some signs of concentration in certain areas, particularly in the upper and middle of the watershed. Japanese Barberry was found in 63% of sites with an average density of 1.8 on a 1-4 Scale. Multiflora Rose (*Rosa Multiflora*) was found primarily downstream, although very few dense areas were observed. Multiflora rose was found in 46% of sites, with an average density of 1.6 on a 1-4 scale (Figures 8-9).

Invasive Species: Results indicate that the area and density of invasive plants continues to grow in riparian areas throughout the Marshalls Creek Watershed. If this trend continues, these invasive populations will continue to spread and replace native vegetations.
