**A GIS-BASED STUDY ON THE GEOMORPHIC
RESPONSES TO
NATURAL FLOODS AND LAND USE/COVER CHANGE
IN THE BRODHEAD WATERSHED: 2007-2011**

FINAL REPORT: MARCH 2012

*Based primarily on work submitted to BWA by:
Dr. Shixiong Hu, Associate Professor of Geography,
and
Dr. Jeri Jewett Smith, Associate Professor of Biology,
both of East Stroudsburg University of Pennsylvania*

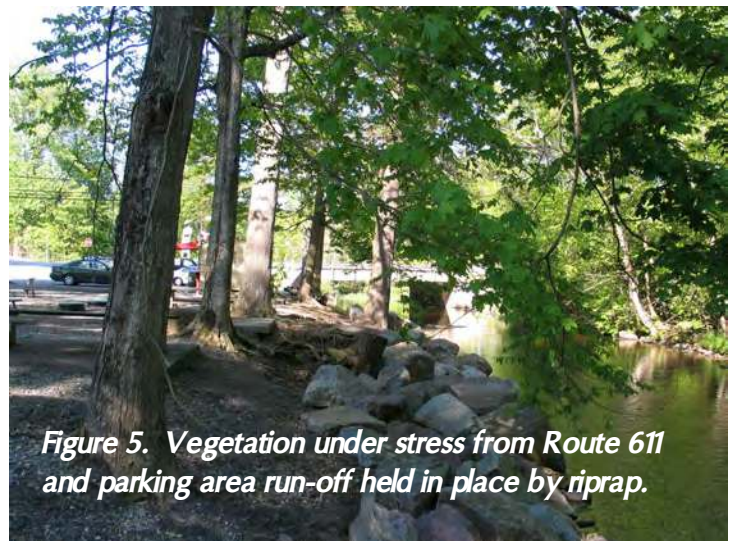
Figure 5. Vegetation under stress from Route 611 and parking area run-off held in place by riprap.

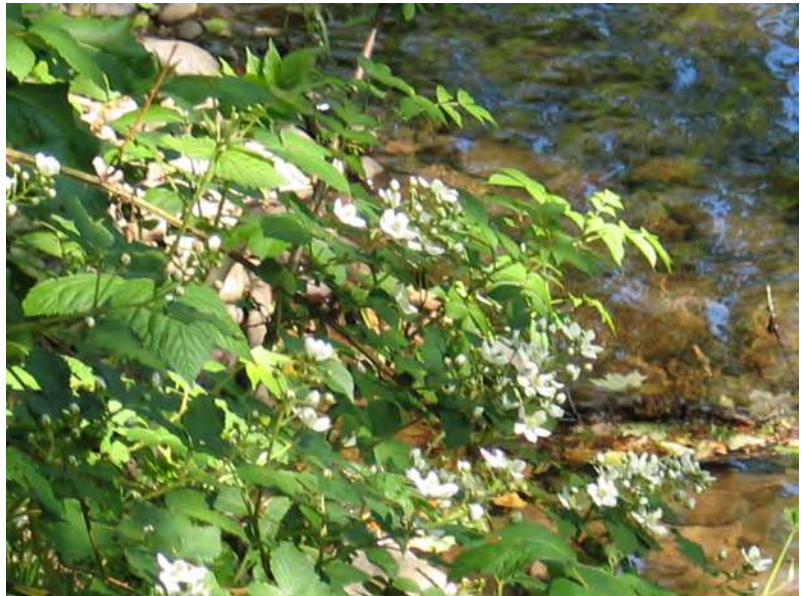
Figure 6. Multiflora Rose at streamside on the McMichael Creek

Invasive plant species have begun to displace many of the native species found in the Brodhead watershed. The problems associated with invasive plant species begin when replacement of native species results in inhibiting the channel's ability to shift morphology. Another problem occurs when invasive species are less resistant to

flooding and results in destabilization of the channel banks. Causes of erosion can come from invasive plant species as well. For instance, Multiflora Rose and Autumn Olive can shade out desirable bank stabilizing native ground cover leaving the streambanks vulnerable to erosion.

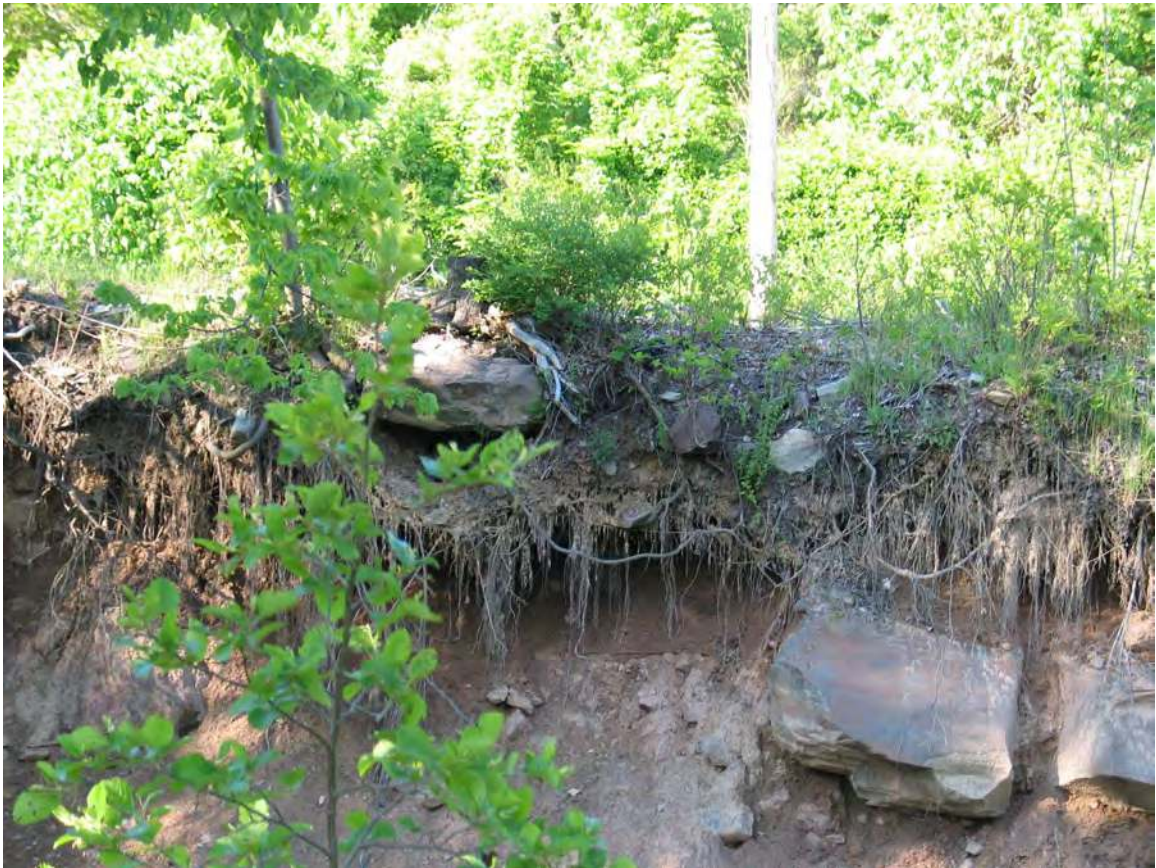
Figure 7. Erosion of steeply sloped bank near Route 611, Tannersville, Pa.

River/stream_bed slope results in straightening a stream channel, impacting river bottom scouring and bank erosion, and increasing the process of erosion resulting in destabilized streambanks.

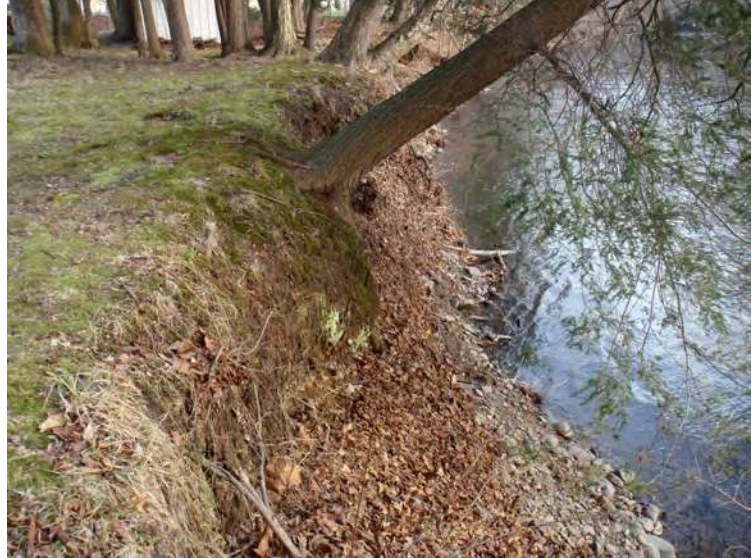
Figure 8. Erosion on steep bank downstream from bridge and meander on McMichael Creek, Stroud Township, Pa.

The sinuosity is the ratio of real stream length over the straight distance of two locations between two locations. A meander in general is a bend in a sinuous watercourse or river. A meander is formed when the moving water in a stream erodes the outer banks and widens its valley. A stream of any volume may assume a meandering course, alternately eroding sediments from the outside of a bend and depositing them on the inside. The result is a snaking pattern as the stream meanders back and forth across its down-valley axis. Previous research indicated that there is a strong positive relation between the sinuosity ratio and the percent of silt and clay in the channel bed and banks.

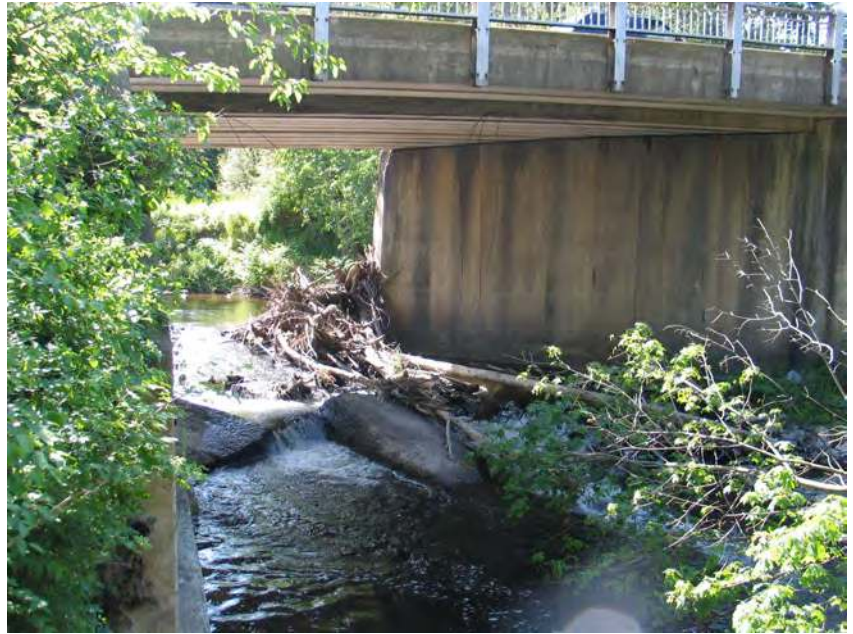
Figure 9. Debris piling up under bridge over Pocono Creek after severe rain event, 2010

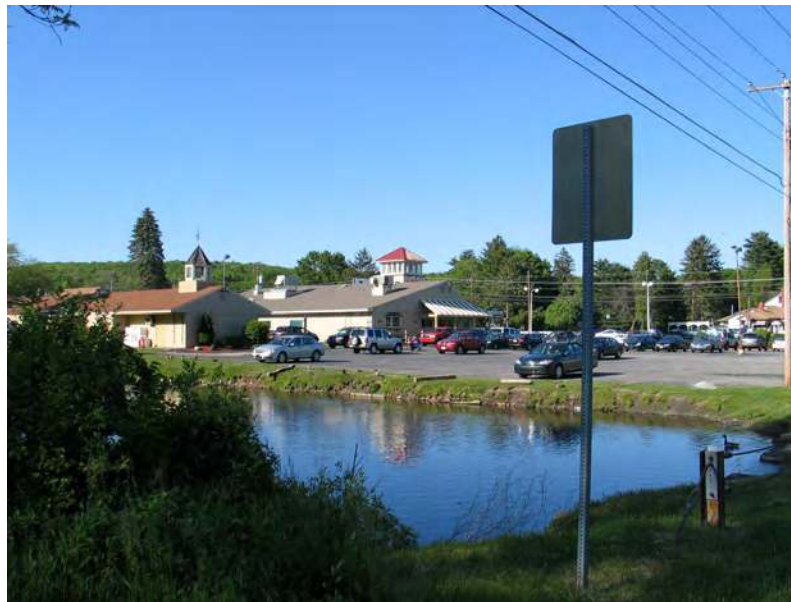
Figure 10. Impervious surface beside pond developed from Pocono Creek, Tannersville, Pa.

Human disturbance in this study was measured by the percentage change of imperviousness above the assessment site.

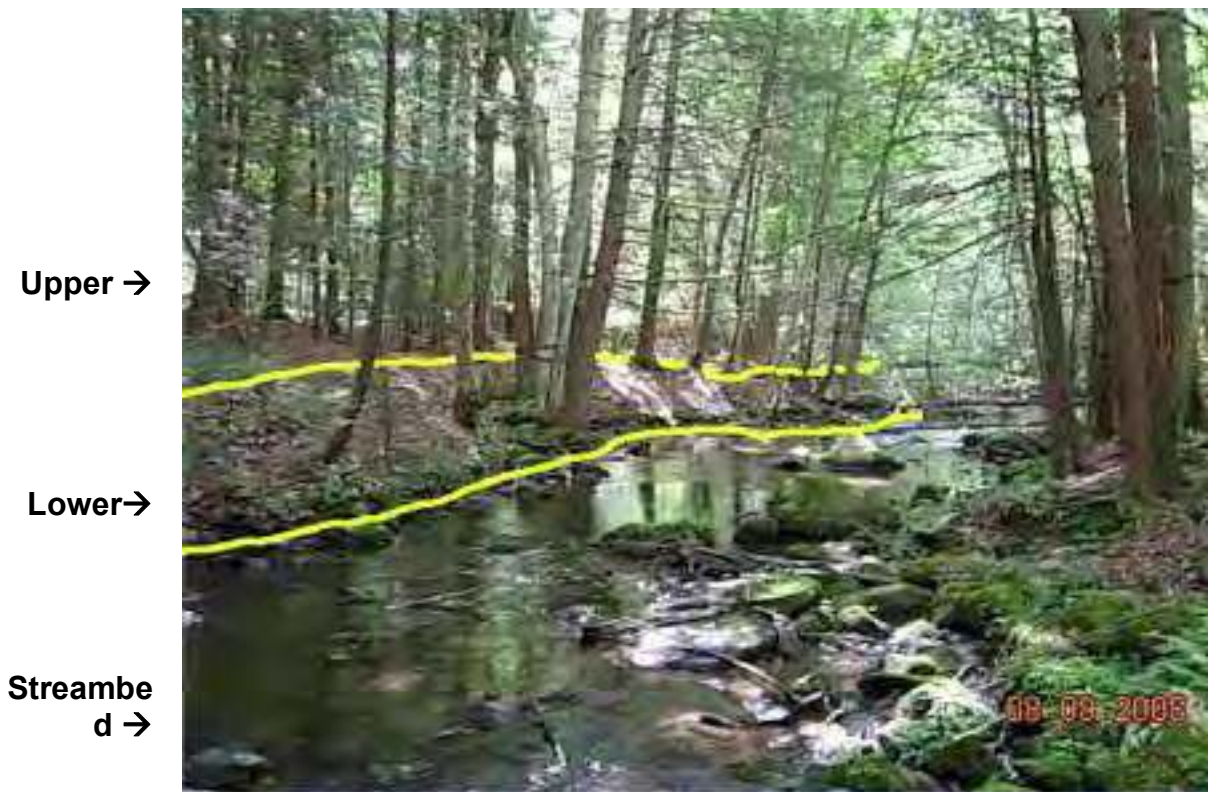
Figure 18: Stream in Brodhead watershed overlaid to display the separate sections analyzed using the Pfankuch-Rosgen method

For each part of the stream channel, certain parameters were applied and rated. The cumulative score from the ratings were then used to categorize the stability of the bank:

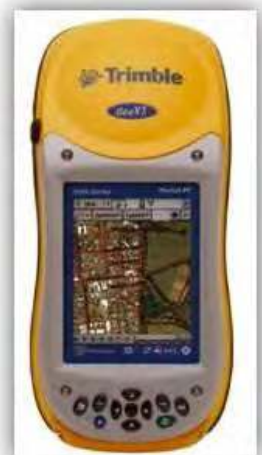
Waypoints at each site inspected were recorded with a Trimble GPS unit to create spatial data to be integrated into the geodatabase. **(Figure 19 (right)).**

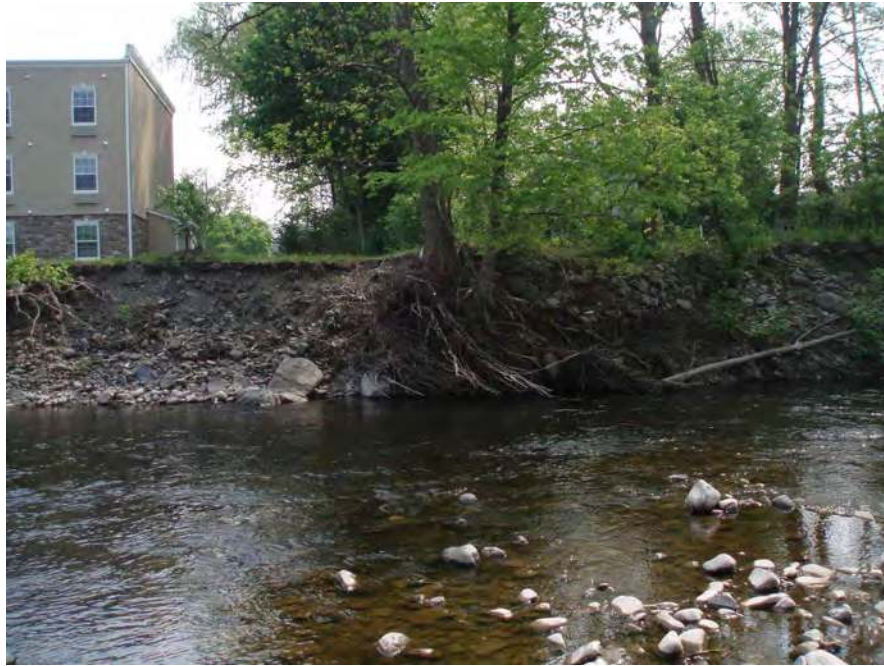
In most areas, sharp bends and meanders in the streambed show excessive cutting.

Figure 24 (photo above), for example, shows serious cutting that occurred below a meander in a bank where residential construction was only a few feet from the bank.
