## **Appendix A -- Demonstration Projects**

## **I. Brodhead Forest and Stream Association**

## II. Buck Hill Falls Community

### III. McMichael Streambank Project

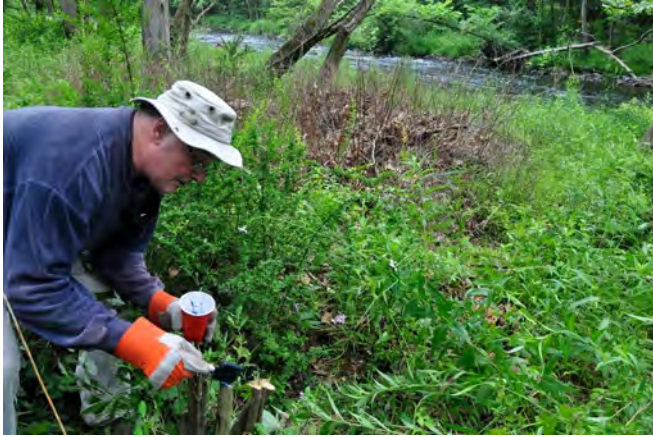
**Figure 28**, on left, shows BWA and BF&SA member Doug Swift, painting

this herbicide on targeted plants.

*Note: the BWA does not recommend the use of herbicide. A generalized (non-target) application of a broad-spectrum herbicide would jeopardize the property's wide variety of native plants and aquatic life. As shown on the image to the left, The BF&SA elected to carefully target specific plants to avoid chemical danger to the stream.*

Because the project was near surface water, Brian McDonnell of the NPS recommended applying the herbicide glyphosate with a non-ionic surfactant to minimize non-target toxicity to aquatic plants and wildlife.

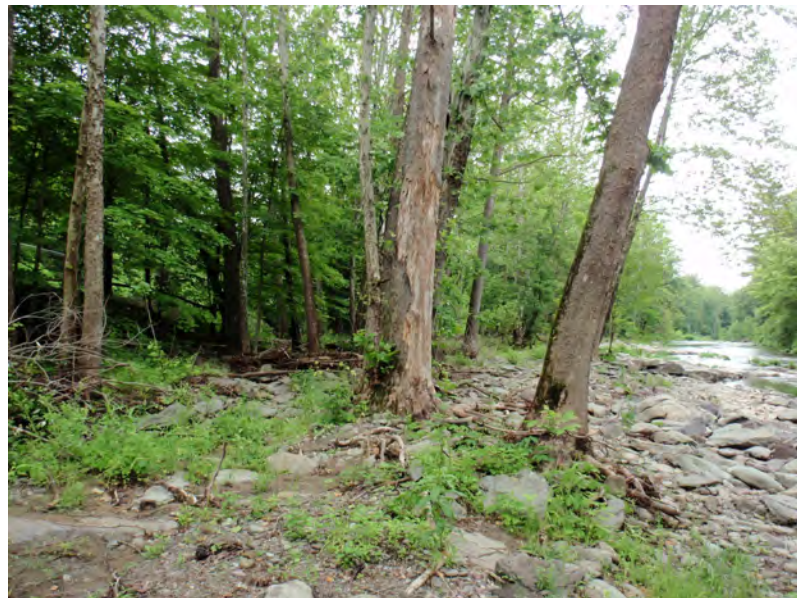
**Figure 29**, above right, shows the condition of the cleared section on June 12, 2011. Very few knotweed have returned. In the distance, knotweed can be seen all along the uncleared section downstream from the cleared site.

An April 2010 inspection showed the knotweed to have been very effectively treated—less than 10% of plants regrowing. The barberry and multiflora that were treated appeared to be dead. The remnant thorny stems, however, proved to be an obstacle to fishermen unless removed. BWA invasive plant specialist, Lori Colgan, attended the April 2010 inspection of the previous removal attempt and emphasized the importance of following the instructions from the herbicide manufacturer and NPS to minimize contamination of the creeks.

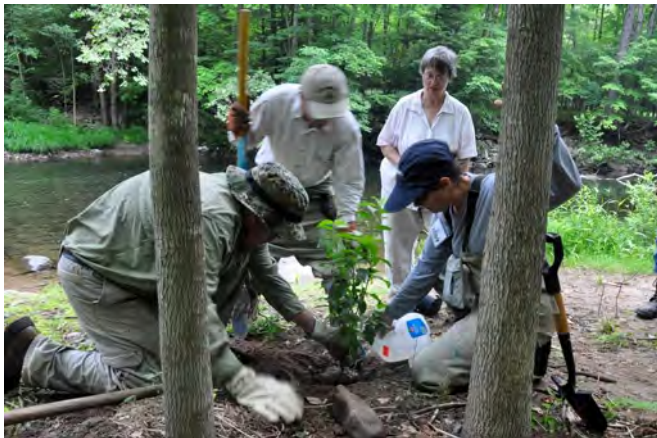
Kietryn Zychal to manually remove barberry and autumn olive and spray of knotweed. **Figure 30**, on left, shows the native plants that had been planted in June were being watered by the fishing club's caretakers and were doing well despite the heat and dry weather that had been experienced.

The Association members also participated in a native plant restoration. Red osier dogwood (*cornus sericea*), black chokeberry (*aronia melanocarpia*), cardinal flower (*lobelia cardinalis*), foam flower (*tiarella cordifolia*), boneset (*eupatorium perfoliatum*), and winterberry holly (*ilex verticillata*) were planted.

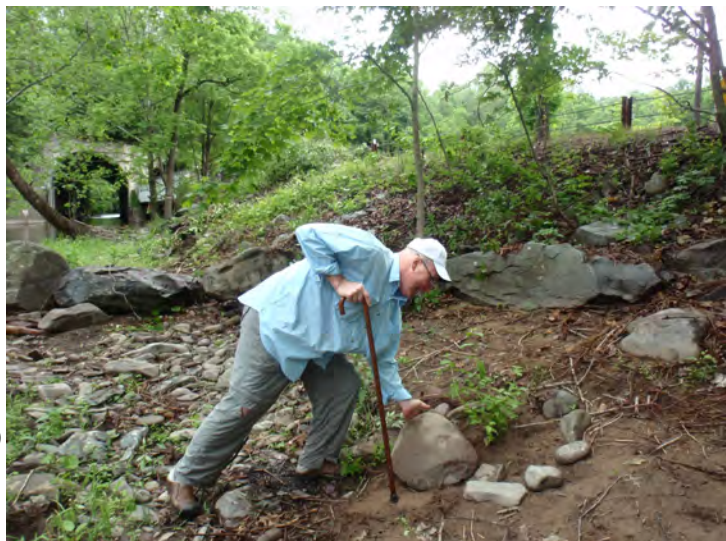
**Figure 31**, on right, taken on June 13, 2011, shows Doug Swift, a member of BWA and BF&SA, replacing stones around newly planted black willows.

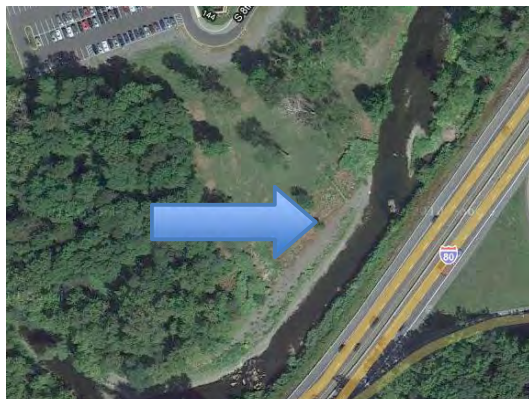
The McMichael streambank at 8<sup>th</sup> and Ann streets, in Stroudsburg (shown on **Figure 34**, a Google satellite map to the left) is a poster child for dense invasion by Japanese knotweed. The problem became intense when a Hampton Inn was built at this location where the McMichael creek runs between downtown Stroudsburg and Interstate 80. In an effort to gain visibility from the heavily traveled interstate, Hampton Inn managers had the underbrush cleared from the

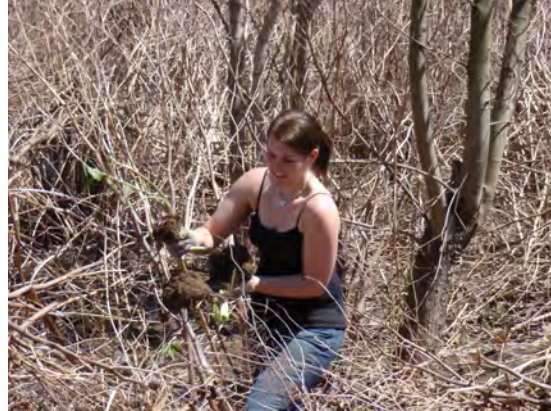
The McMichael Creek at this location is also a popular fishing spot. The Brodhead Chapter of Trout Unlimited decided to undertake a knotweed removal project along the bank; BWA volunteers, accompanied by ESU students, joined in the effort. (See **Figure 35** below (ESU student volunteer) and earlier **Figure 10**, p. 22).

On April 26, 2009 a group of 22 volunteers, dug, pulled and carried 6 large pickup loads of this highly invasive, rapidly growing weed off the bank of the McMichael Creek.

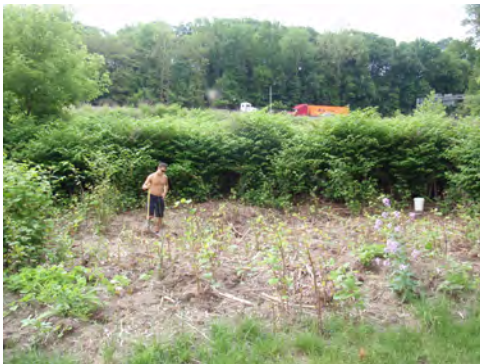
**Figure 36**, to the left, shows the BWA's student intern from ESU on May 30, 2009, attempting to fight back the knotweed that was re-invading the cleared patch.

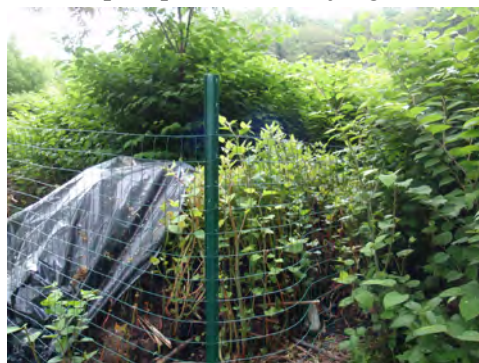
At first an attempt was made to compost the stalks on site. However, as shown on **Figure 37** (below left) that effort failed and the compost pile became a jungle of regenerated knotweed.

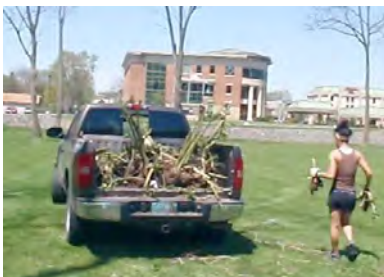
**Figure 38**. With the help of BWA volunteers, the knotweed stalks were taken to a nearby landfill.

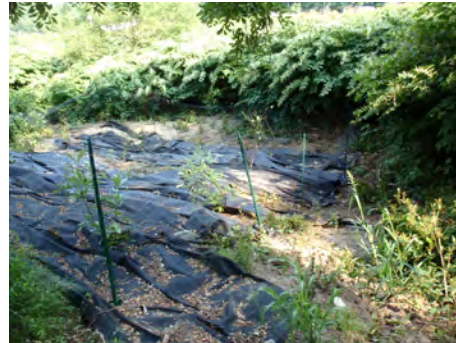
A small area was selected for a demonstration planting and native shrubs planted, weed barrier cloth installed and the area fenced in. See **Figure 39** (below right).

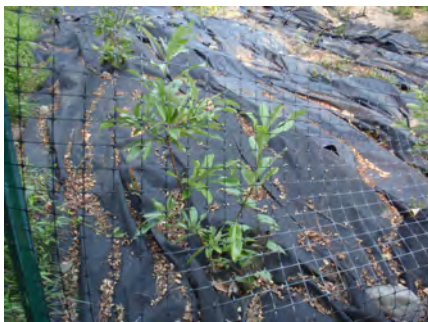
The intern maintained the planted area over the summer while the surrounding area grew into a forest of knotweed. Over the following winter the fence was knocked down by deer and many of the shrubs eaten. However, in the Spring of 2010 a watershed resident required to undertake a community service project restored the fence and the weed cloth and the shrubs began to bud out. (See **Figure 40** to the right and **Figure 41**, below right).

Neither BWA nor Trout Unlimited had a volunteer willing or able to “adopt” the site, nor did either group have funds to pay another intern. Since young knotweed plants were already beginning to grow through the weed cloth barrier, we decided to give up the project. The remaining fence and weed cloth were removed and the site given over to re-growth of knotweed.
